## Stormwater Rapid Condition Assessment Town of Longmeadow, Massachusetts

**To:** Town of Longmeadow, DPW  
**FROM:** Katie Weaver, GIS Analyst (Tighe & Bond)  
**COPY:** Libby Baldwin, Sam Swartwout, Jennifer Gilbert (Tighe & Bond)  
**DATE:** June 28, 2019

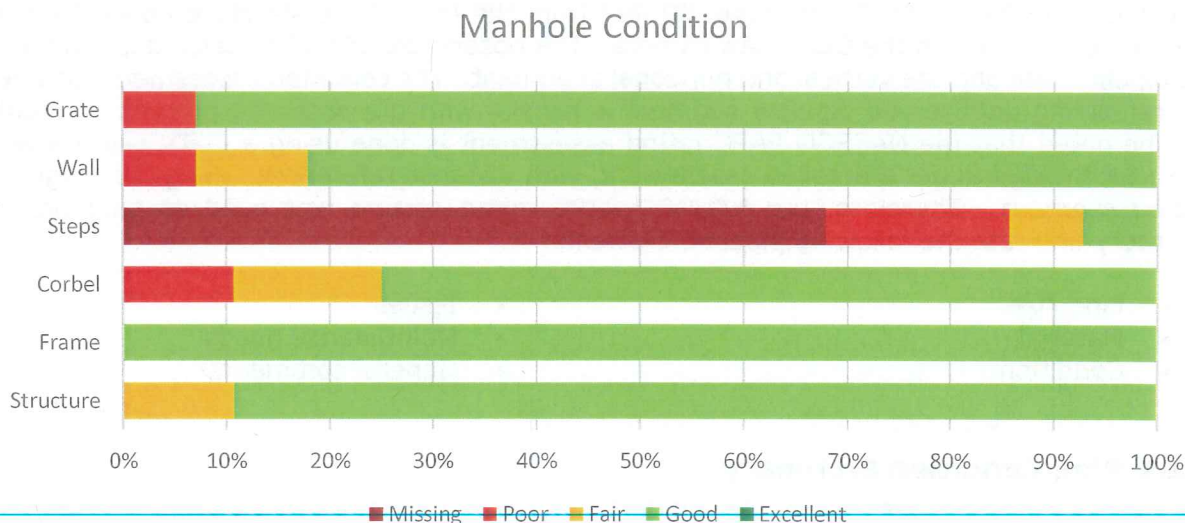
### 2.1.1 Manhole Condition Summary
